EXTERNAL MURALS OF THE TRINITY GATE CHURCH OF THE KYIV-PECHERSK LAVRA. HISTORY OF CREATION, PROBLEMS OF PRESERVATION AND RESTORATION

Abstract. The research article is devoted to the history of the creation and restoration of external wall paintings of an architectural monument of national significance – the Trinity Gate Church of the Kyiv-Pechersk Lavra. The relevance of the article is conditioned by the need for a comprehensive study of the monument due to the loss of authenticity as a result of late repairs, alterations, renovations, as well as the beginning of restoration work on the facades of the Church. The purpose of this article is to summarize the previous practical experience in the restoration of architectural and pictorial heritage using the mural painting of the Trinity Gate Church. Using materials from archival sources as well as design and restoration documentation, the main periods of changes in the appearance of the temple and restoration interventions are outlined. The characteristic of the current state of the monument and recommendations for its preservation are given

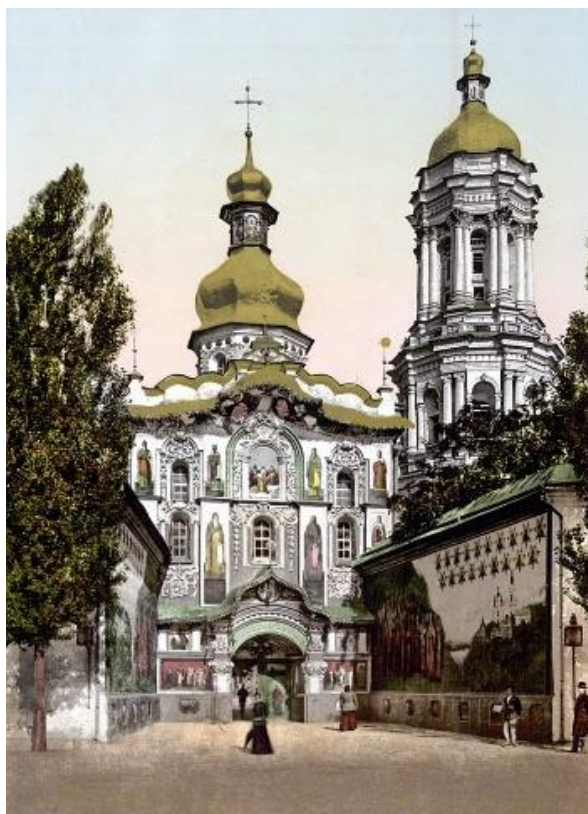
Figure 1. Trinity Gate Church. Photo 1890 .

late additions *"represent such an antiquity that should be preserved, since it is clear from the chronicle that the given Church was renovated by Mazepa in the 18th century"*. However, the proposal to restore the painting in the ancient style, the Lavra authorities supported. After the preliminary taking of the drawings, the stucco moldings were restored. The pictorial images of the saints, adorning the walls of the Church, were made in the oil technique on a zinc base *"in the same form and in the same places"* (Fig. 1).

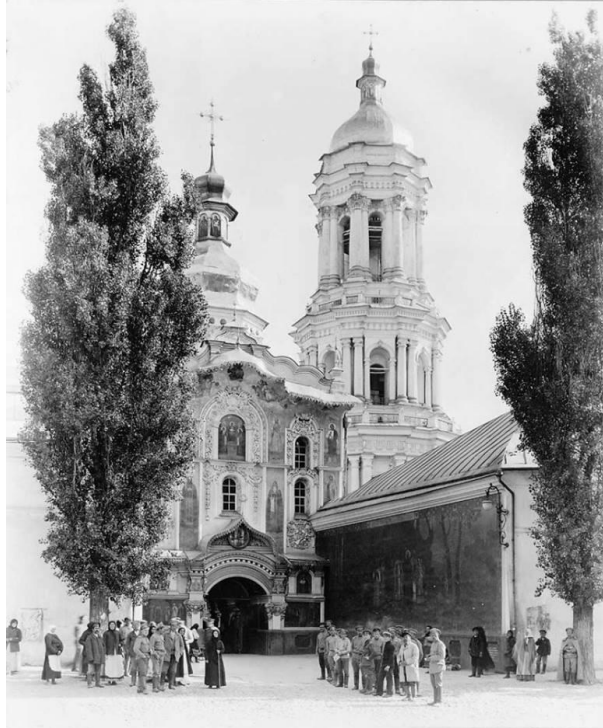
Figure 2. Trinity Gate Church. Photo the early 20th century.

The exterior of the Church underwent the last radical changes in the painting decoration in 1900-1902. Kyiv icon painter Vladimir Sonin was invited to restore the exterior painting of the Trinity Gate Church. Having taken the patterns from the old compositions, Sonin cleared the layer of paints to the zinc base and reproduced all the images of the Holy Door in oil painting technique (Fig. 2). As a matter of interest, some of the subjects that were present on the facades of the Trinity Church before 1900 disappeared for ideological reasons. Thus, the subject "The Coronation of the Virgin Mary by the Holy Trinity", which was located in the center of the western facade, was removed as having its origin from the Western culture, and replaced with the image of "Our Lady of the Caves with St. Anthony and St. Theodosius" [9, sheet 5].

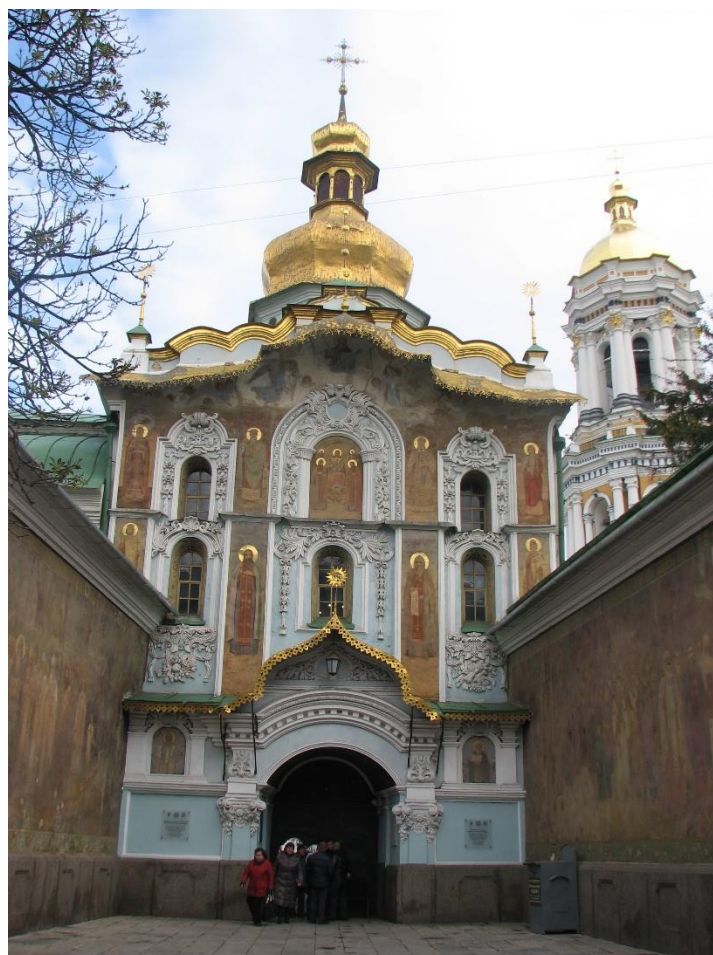
Figure 3. The western façade Trinity Gate Church . The current state.

However, not all the recommendations of the specialists were implemented, and the issue of preservation and restoration of the exterior murals of the Trinity Gate Church is still essential. Under the influence of ultraviolet light and atmospheric precipitation, the pigments discolored, and weathering and constant fluctuations in temperature and humidity affected the binder of the painting layer. Cracks, a mesh of crack patterns with active peeling of the paint,

decomposition of the cover layer, dirt accumulation, and soot from vehicle exhausts are traced on the surface of the painting. Paintings on metal are also in unsatisfactory condition. The wavy deformation and general weariness of the zinc base, local corrosion centers, as well as minor metal losses at places of attachment to the surface of the walls are observed. Painting is performed in several techniques on a layer of lead minium on an oil binding. The painting layer is thin, with pastose loads on sections of light, and has many late tints and notes (Fig. 3).
